**Enbridge Line 6B MP 608 Pipeline Release
Marshall, Michigan**

**Permanent Recovery of Submerged Oil and Oil-Contaminated
Sediments at Priority Locations**

Submerged Oil Recovery Summary Report

**Enbridge Energy
October 29, 2010**

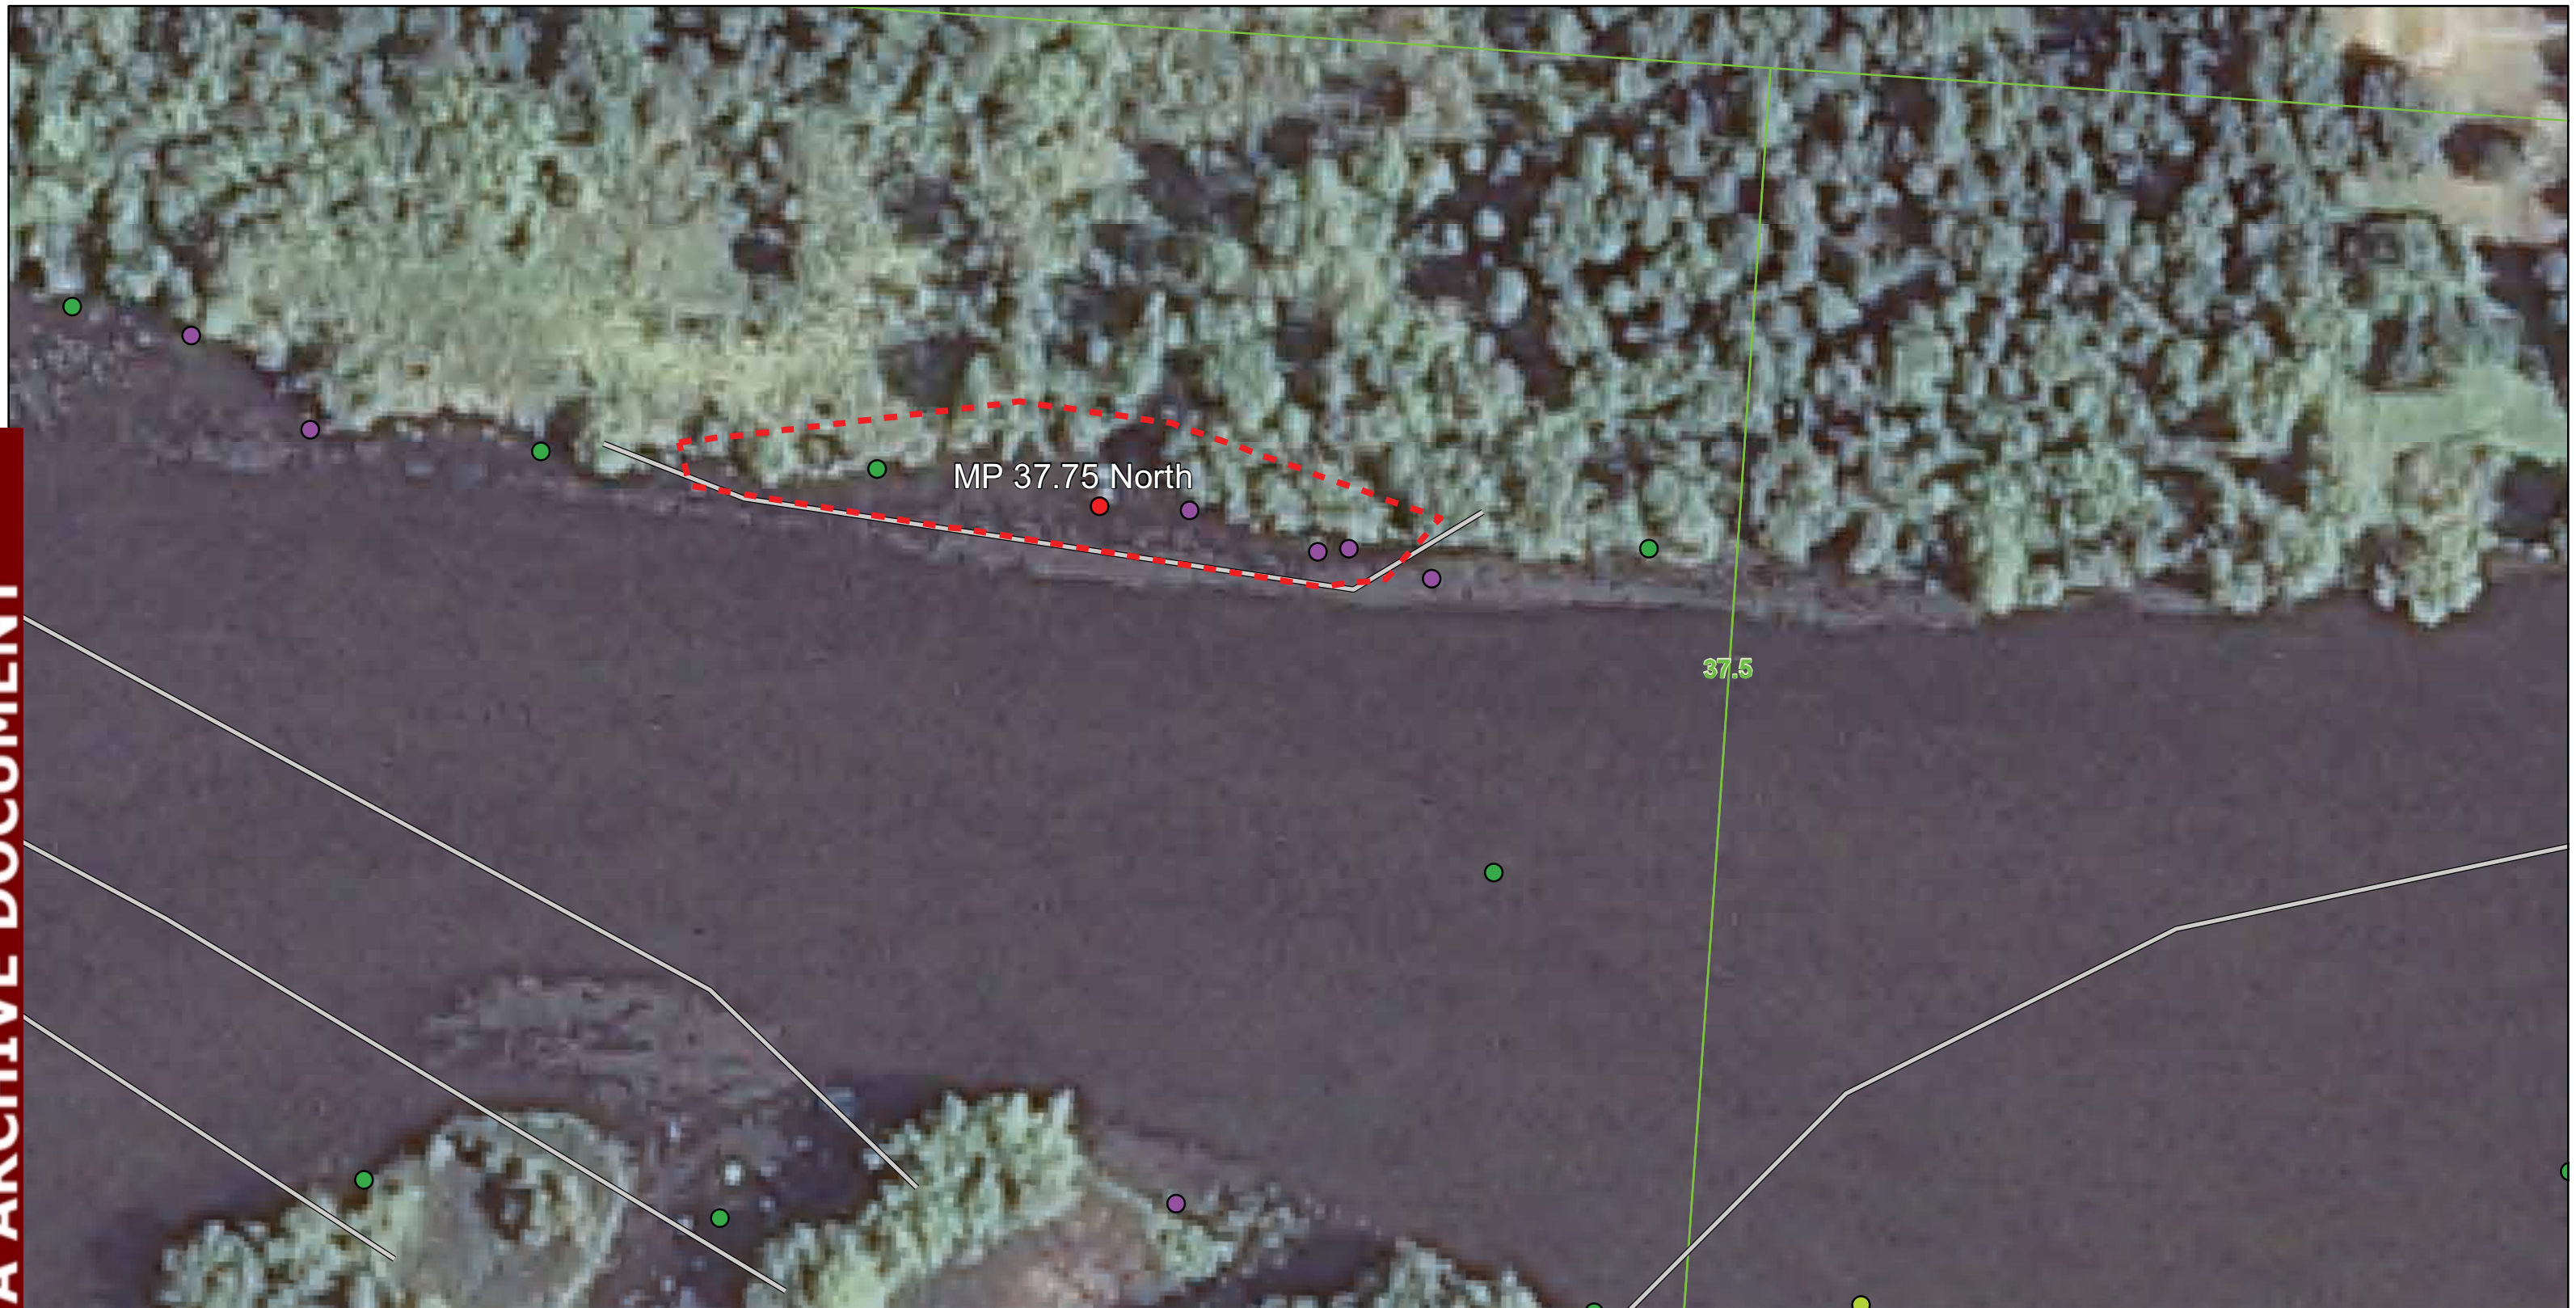
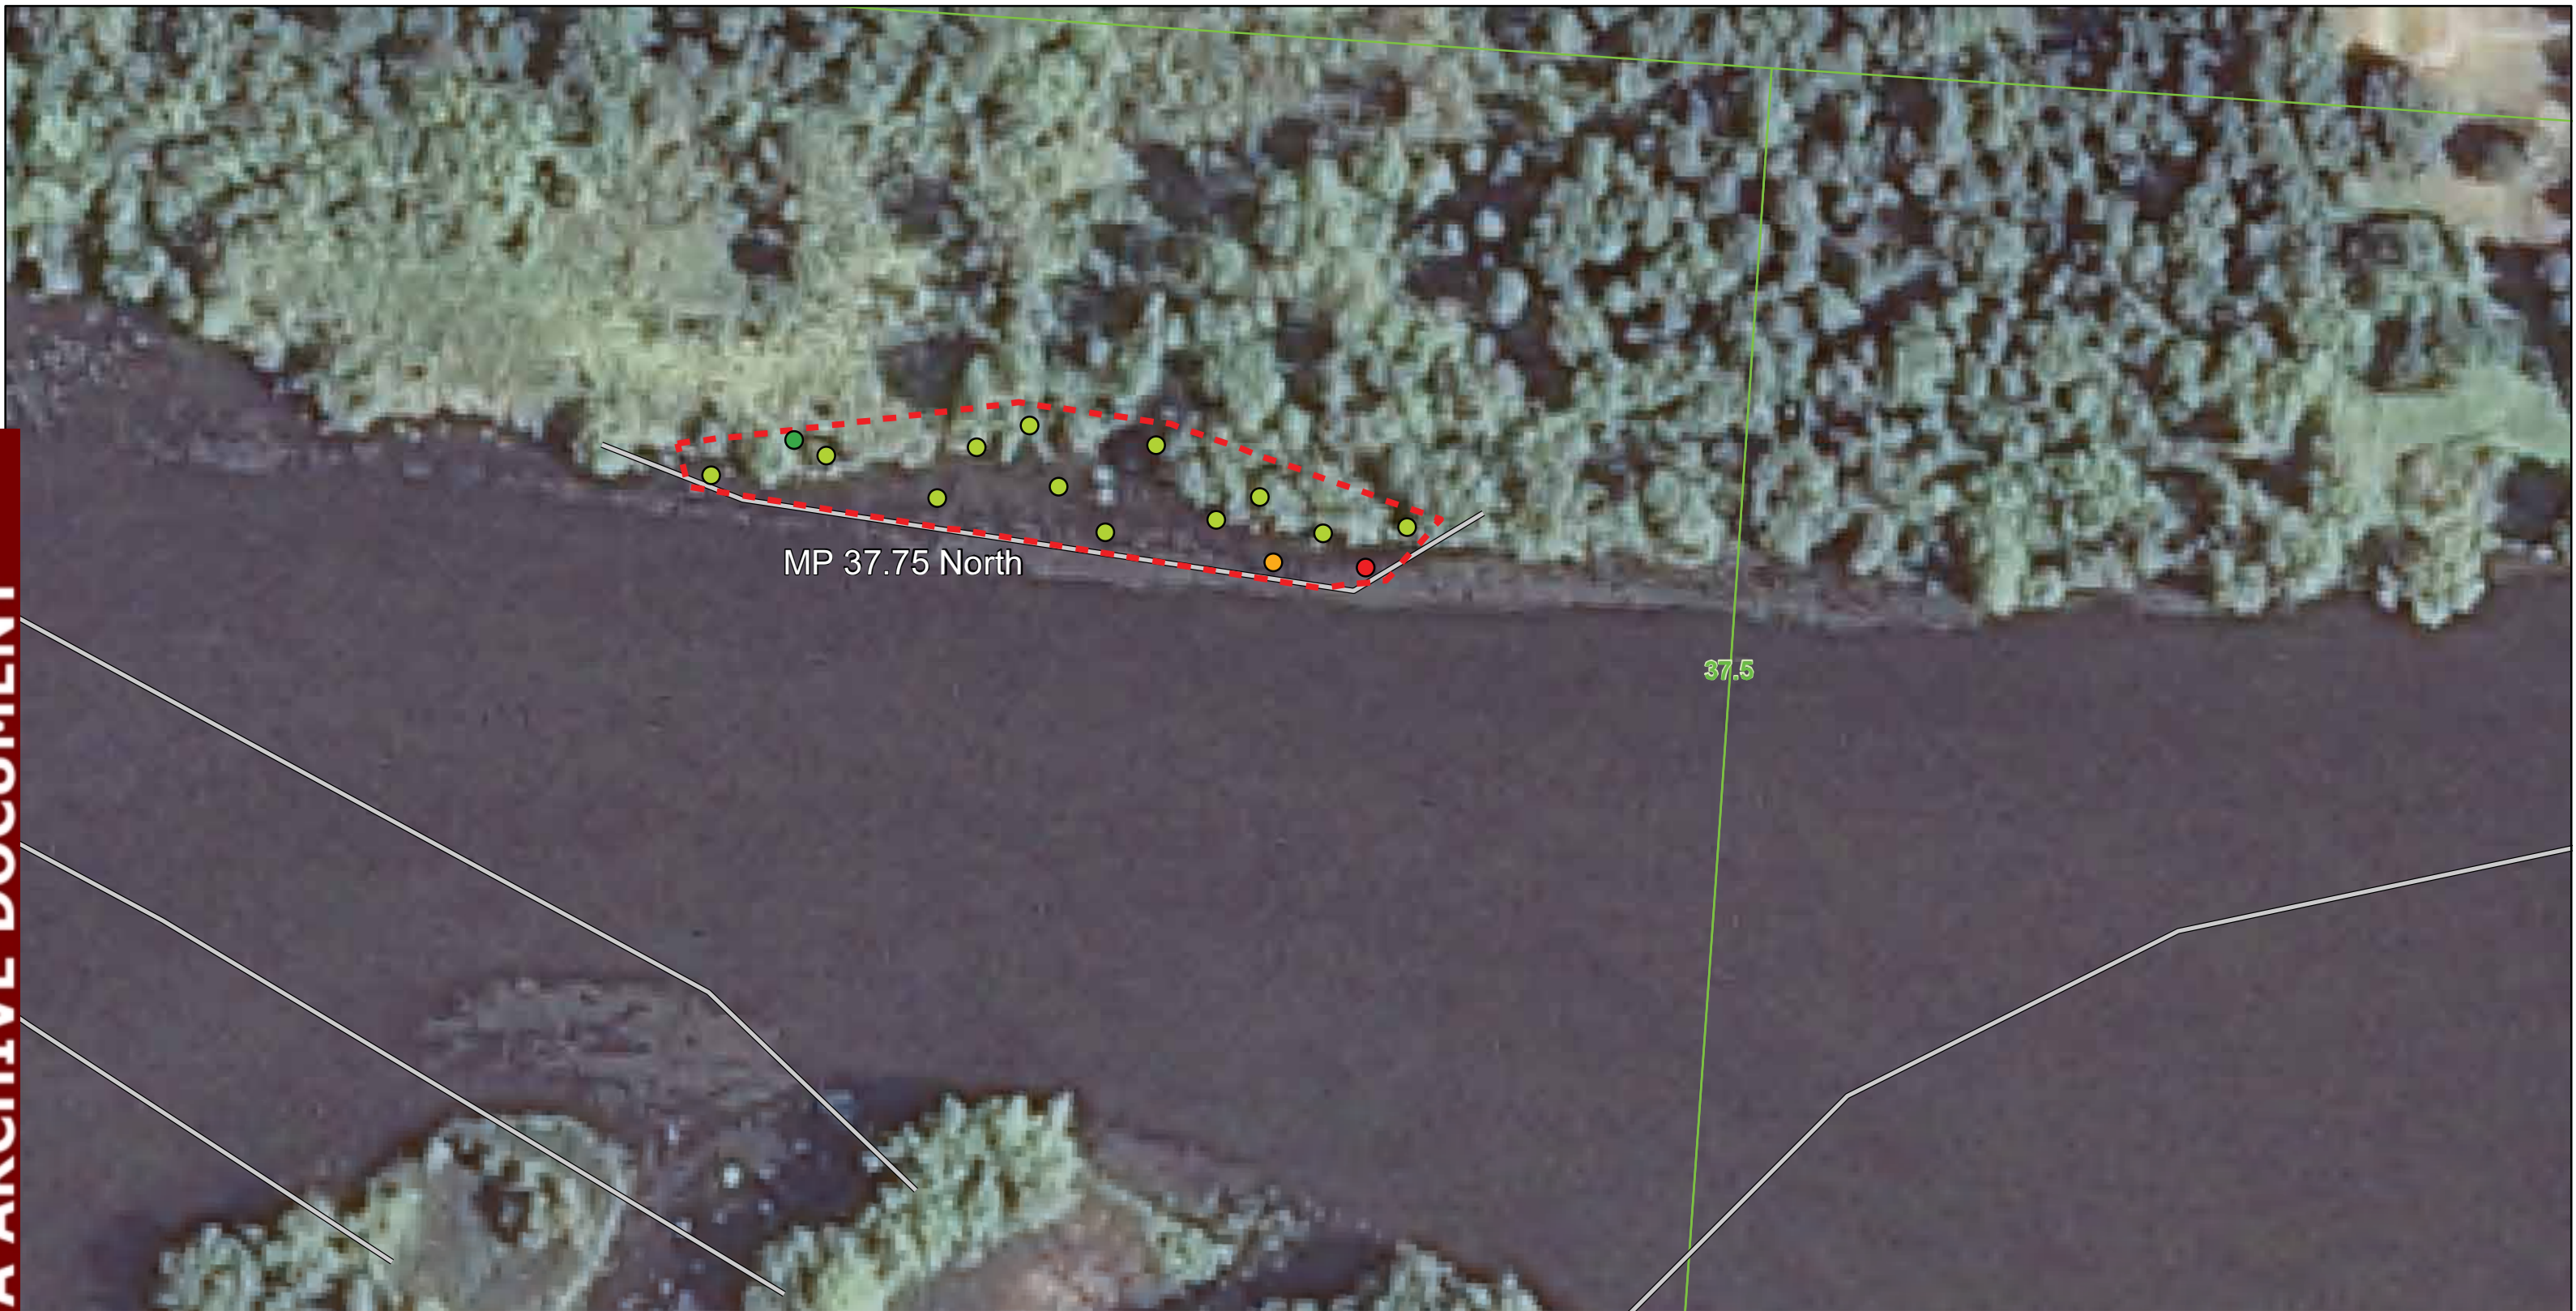
Site Location:	MP 37.75 North
Site Layout:	See Figure Attached
Description and Geomorphic Setting:	Shoreline, right bank
Approximate Areal Extent:	~0.5 acres
Approximate Depth of Water:	2.5 to 3 feet
Sediment thickness:	0 to 0.5 feet
Bed type:	Sand and gravel
Data Collected:	
Poling (Y/N)	Y
Cores (Y/N)	Y
Lab analysis (Y/N)	Y
Community Description and Habitat Quality:	Not provided in Ecological Assessment Reports
Containment:	Containment boom and X-Tex curtain
Access Issues:	None
Miscellaneous:	N/A
Rec. Action:	ECO: Not provided in Ecological Assessment Reports SOTF: Less aggressive invasive action at this time. Cautious raking and flushing, taking care to avoid damage to existing vegetation.
